IPED Annual Historic Tax Credit Summit 2018

CINCINNATI UNION TERMINAL

Existing Conditions
Assessment

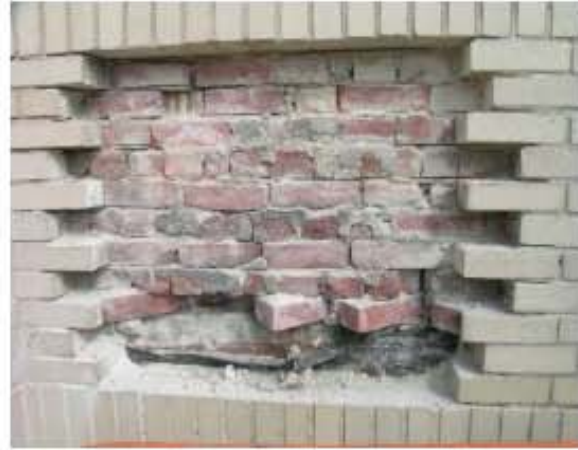
Probe: A-11/S-11 Project 1 Parapet

Purpose: Remove portion of brick wall to verify construction of parapet and determine cause of excessive lime leaching.

Findings: Diagonal brick and headers were used to tie the masonry wythes of the parapet together. Existing mortar is mealy in texture. Fabric membrane at roof slab level is deteriorated.

Conclusion: Project One parapets to be partially rebuilt. Remaining brick masonry to receive spot repointing.

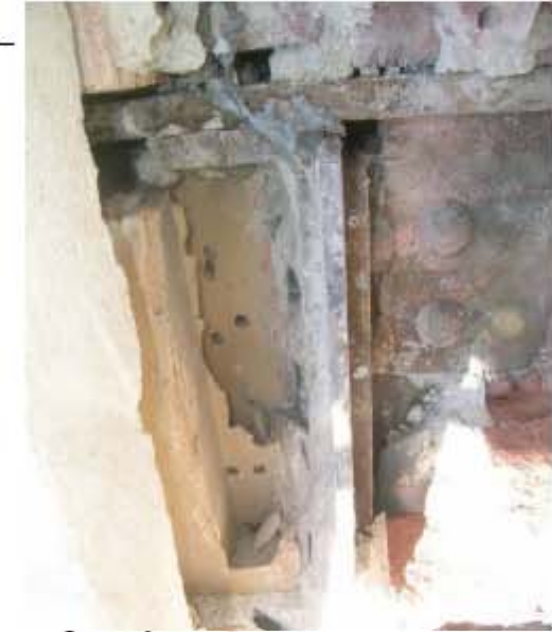
Probe: A-12a Upper Office Wall

Purpose: Remove portion of brick wall to expose and verify condition of structural steel beyond.

Findings: Existing steel is in good condition, with minor surface rust.

Conclusion: While steel structure at many building corners and parapets exhibit significant rusting, steel structure between these areas does not exhibit the same level of deterioration.

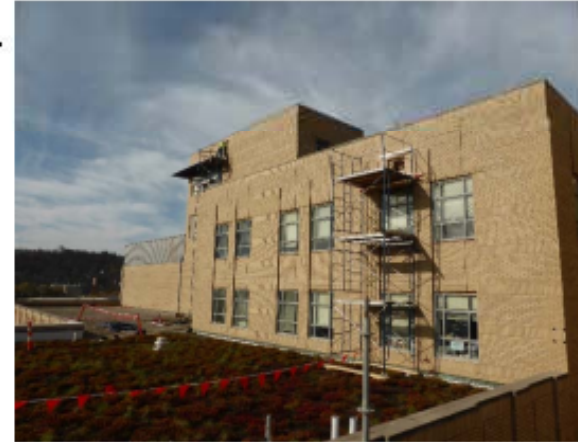
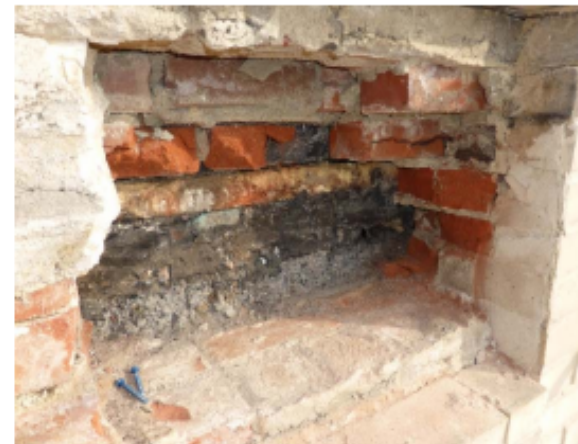
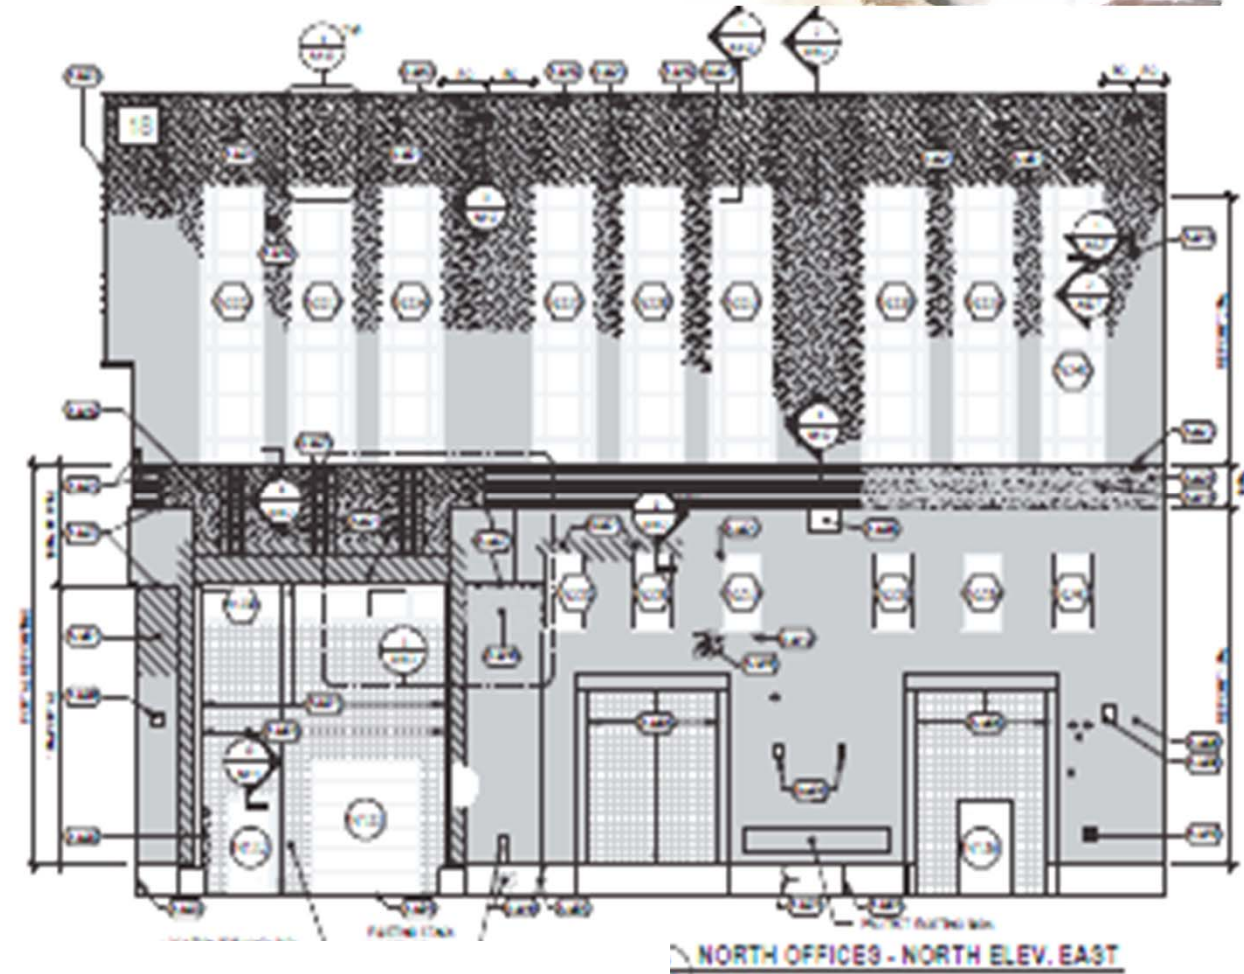
Probe: A-12 Upper Office Parapet

Purpose: Remove portion of brick wall to verify construction of parapet to expose structural steel beyond. Determine cause of cracking and brick displacement above upper windows.

Findings: Existing steel framing at the roof level has deteriorated and is displacing masonry. Over 1/2-inch of pack rust was observed on the spandrel beam and the backup brick was displaced outward up to 1 inch.

Conclusion: Parapets need to be rebuilt and surface brick properly tied to steel structure and backup masonry. Steel should be exposed, prepared, and painted at parapet locations. Steel should be reinforced at areas of substantial section loss. New waterproofing and backup masonry should be installed.

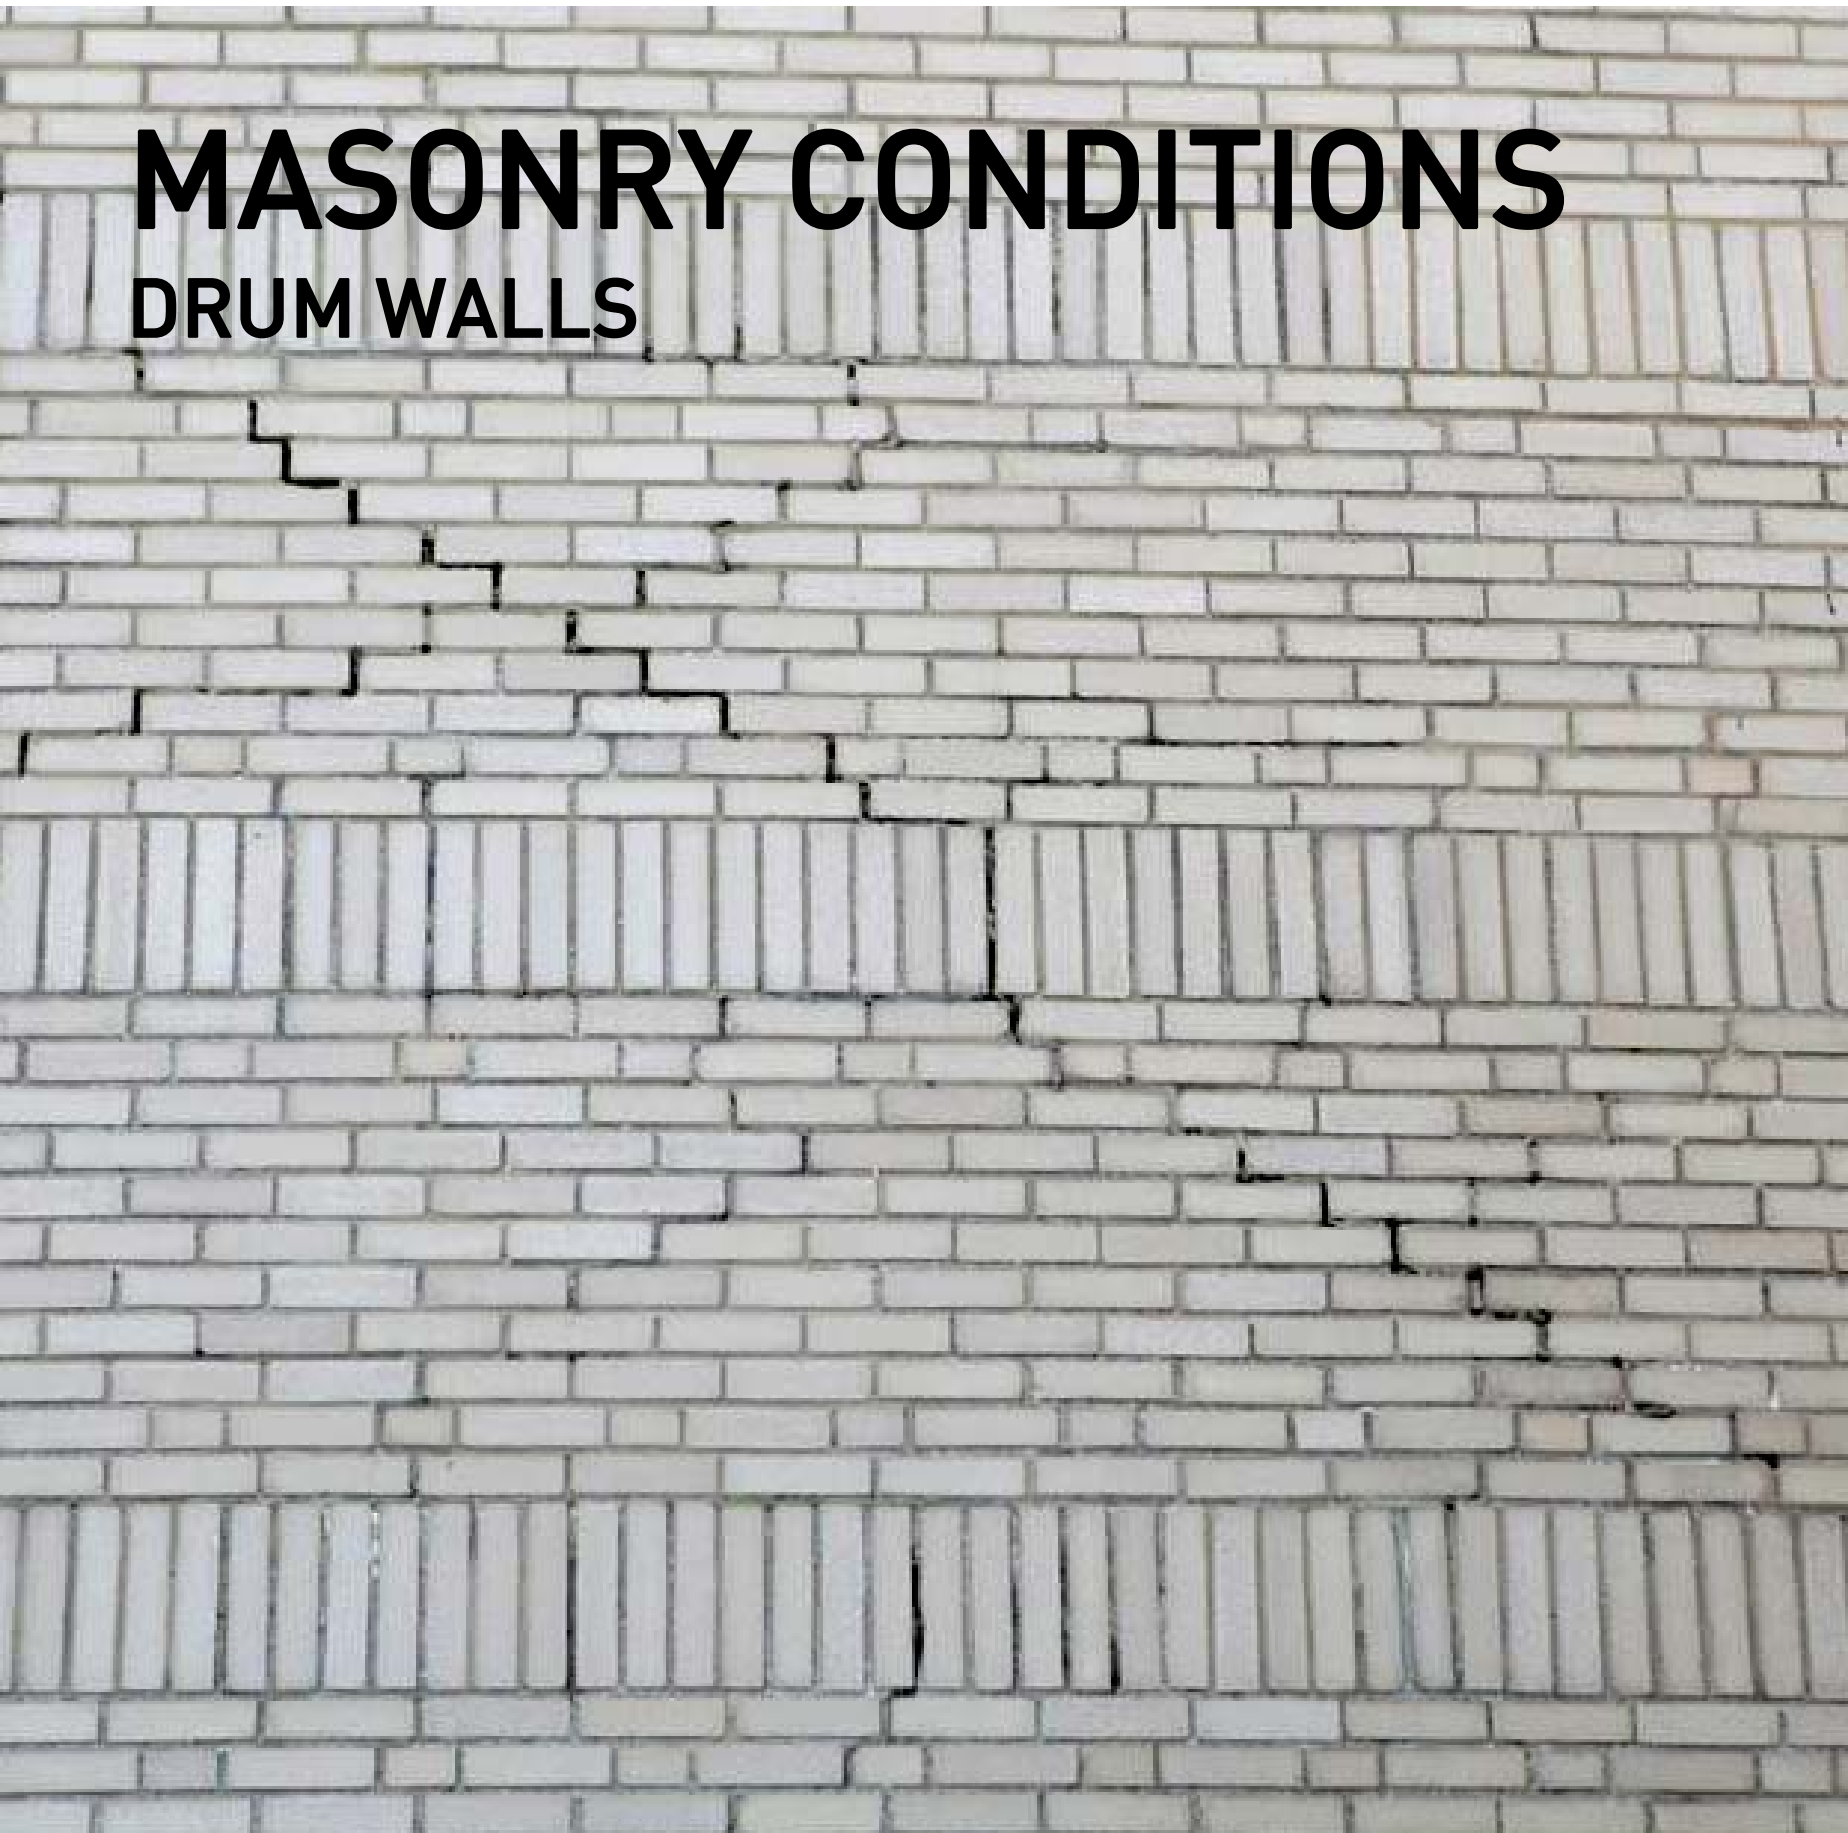
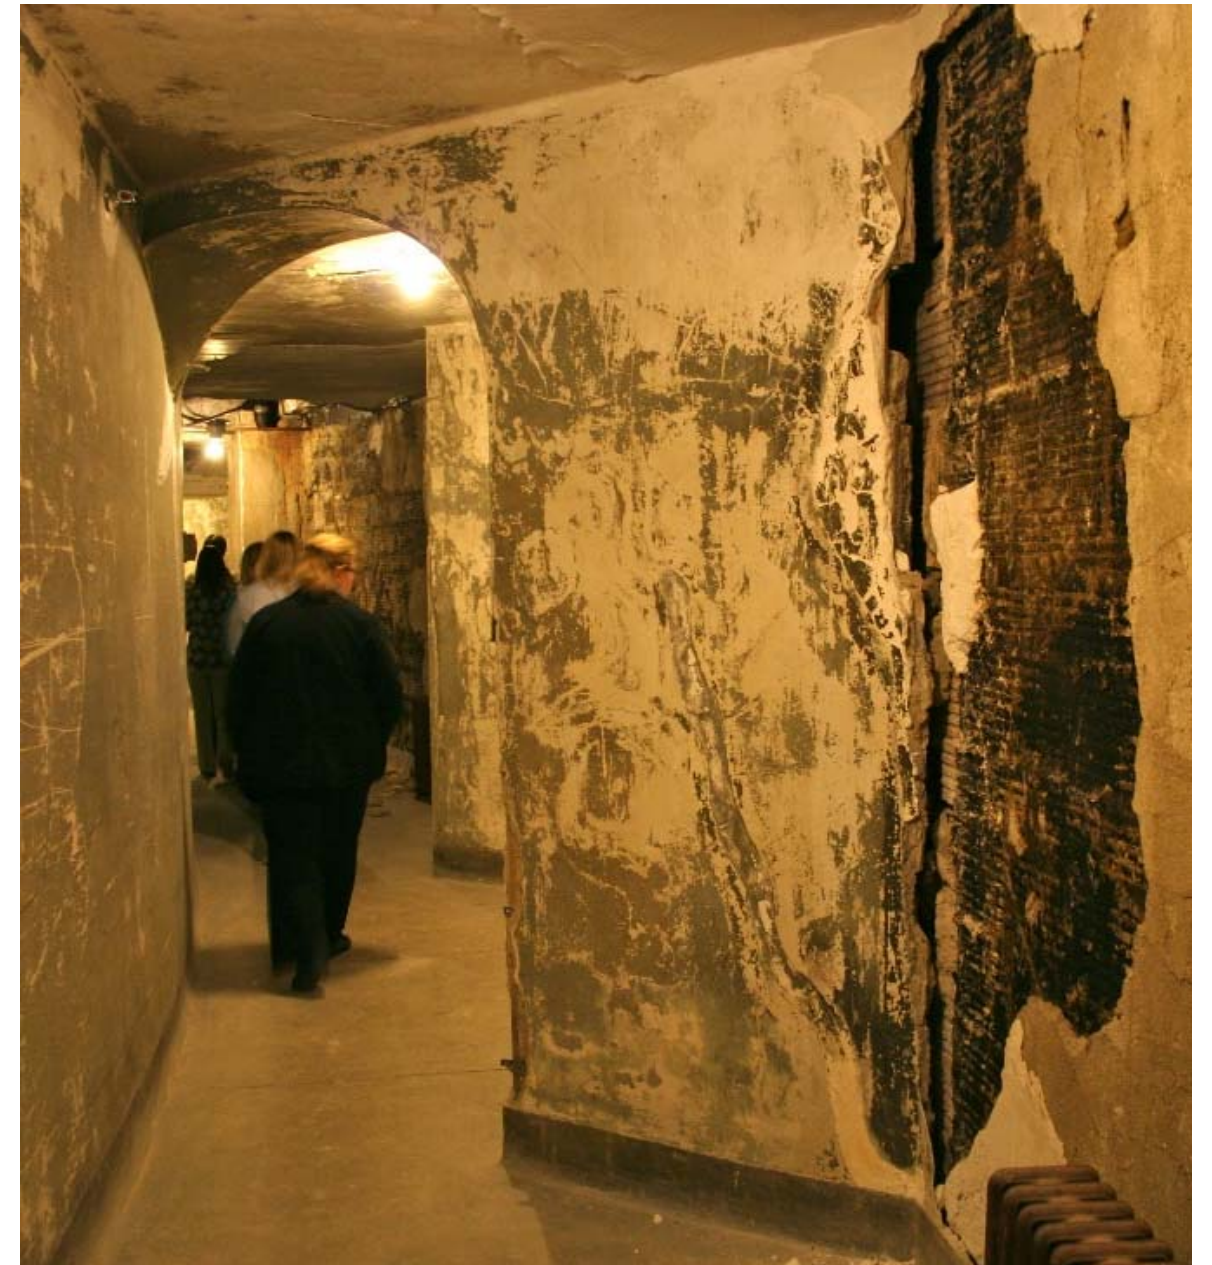
MASONRY CONDITIONS

DRUM WALLS
